## Lessons for Insurance: Risk Management and Engineering in the major Earthquakes of 2010-2011

Peter Yanev & Alexander Yanev

Yanev Associates, California, USA

### ► Lessons and Opportunities for Insurers and Insureds

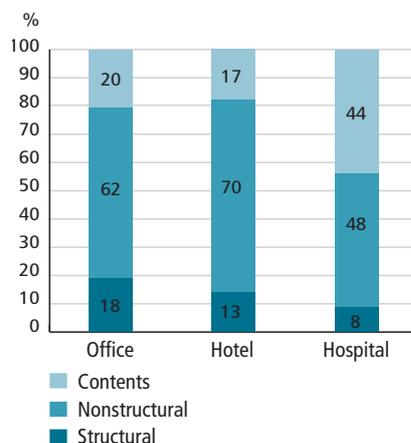
Figure 1. Relative investment costs for new buildings - comparison of structural, non-structural, and content costs for typical classes of buildings. (Federal Emergency Management Agency, 2011).

This is a relatively new and an interesting development in earthquake engineering. Figure 1 below shows the relative investment costs in the Western United States of the structural part of a building vs. the non-structural parts (suspended ceilings, finishes, equipment, tenant improvements) and the physical contents of buildings. The graph shows office buildings, hotels, and hospitals (which have expensive equipment and contents). The structural costs of a modern building are typically between about 8% and 15% of the total value. The rest is made up of finishes and contents. Again, the codes require earthquake protection for the structures and minimal protection for the non-structural portion, which makes up 50% to 70% of the value of the building. Effectively, today's earthquake insurance is covering the finishes of a building.

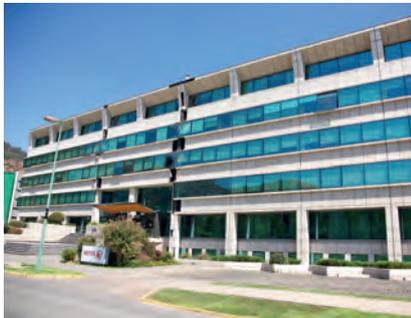
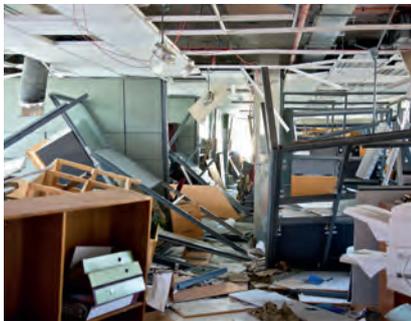
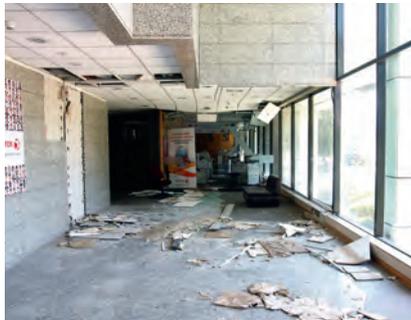
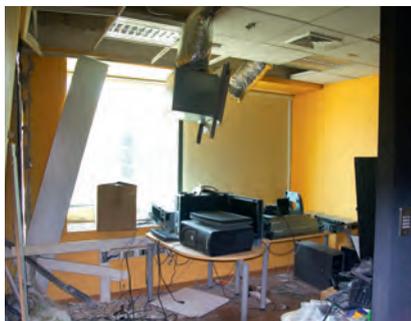
**Figure 2.** Structurally undamaged new concrete building in Santiago (upper left). Note the undamaged windows in the lobby and the water damage from broken water pipes in higher floors in the photograph on the upper right. The lower two photographs show interior damage to inadequately braced office partitions, suspended lights and other fixtures, suspended ceilings, suspended heating, air-conditioning and ventilating equipment, computers, etc.

Figure 2 below shows a typical example from Santiago, Chile. The five story office building (upper left) is surrounded by many other new buildings and buildings under construction in a new business park. The building was structurally undamaged but the interior was essentially destroyed. The loss is in the order of 50% or more, without structural damage.

is that the building in Figure 7 is very stiff whereas the building in Figure 2 is relatively flexible (it is typical of similar buildings in California). Both buildings housed computer centers. Business interruption lasted many months for Figure 2 and just a few weeks for Figure 7. Damage to the overall business park, the unavailability of labor, and damage to the utilities serving the business park caused the business interruption for the building in Figure 7. All of these variables can only be predicted through engineering loss control assessments, which can then be included in the models.

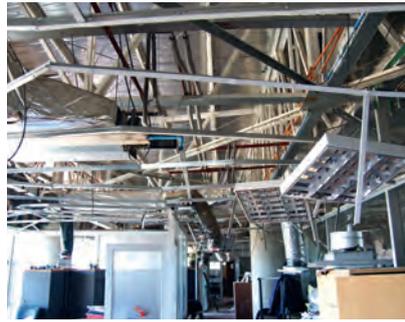
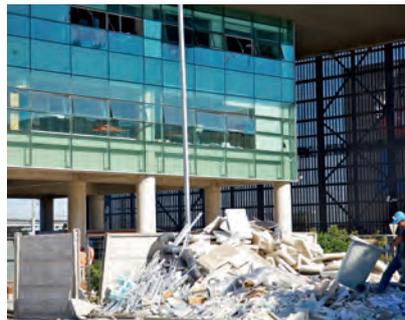
**Figure 3.** Damage to a transportation computer center inside an undamaged building in Concepción, Chile. Note the undamaged glass facade of the building. The third photograph shows a server room with inadequately braced/anchored and now destroyed servers, IT equipment cabinets, and other related equipment.

The damage was typical throughout Chile, New Zealand, and Japan, as also shown in Figures 3 and 4 below. The damage shut down for extensive periods structurally undamaged office and retail buildings, hospitals, industrial buildings and complexes, airports, computer and control centers, etc.

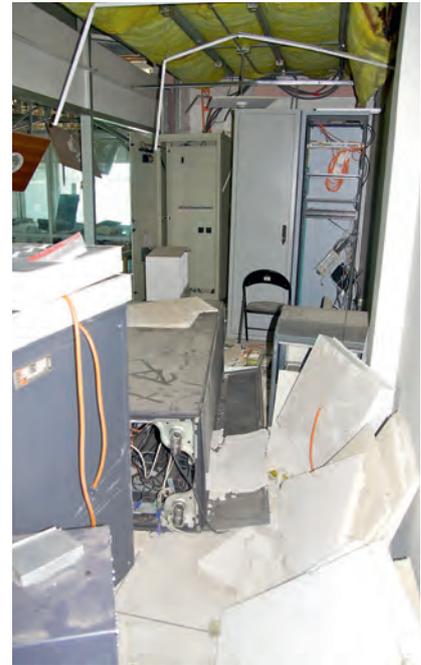
**Figure 4.** Christchurch, New Zealand. The damage to the facade of this shopping mall building was caused by the sliding (movement) and collapse of rooftop-mounted air handling equipment that was not anchored properly. A remaining air-handling unit can be seen in the upper right. The interior non-structural elements of the building were also damaged extensively.

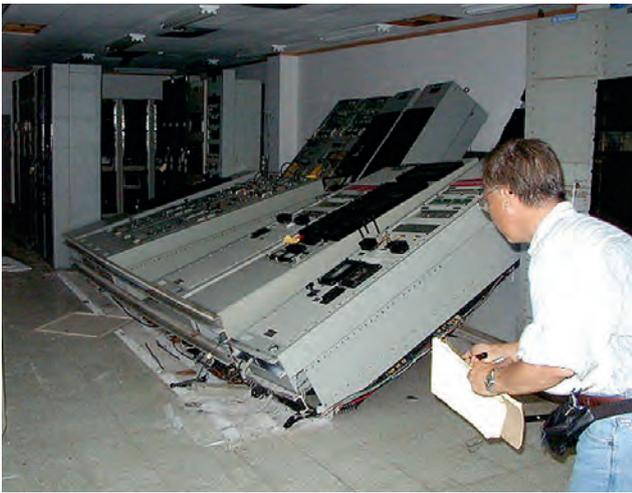
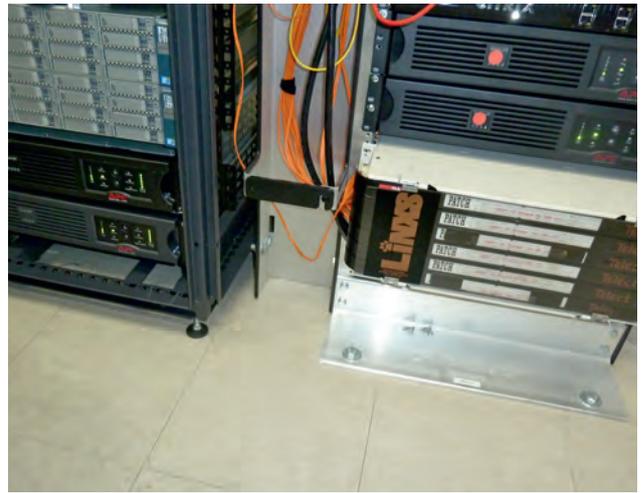
**Figure 5.** Unanchored and tipped-over electrical equipment in the 1999 M7.6 Central Taiwan earthquake. The solution (anchor bolts) is shown on the right of the right photograph. That particular IT rack is standing next to another one that is not anchored and that will fall over in a strong earthquake. The racks are part of the control system for a major Metro system in the U.S.

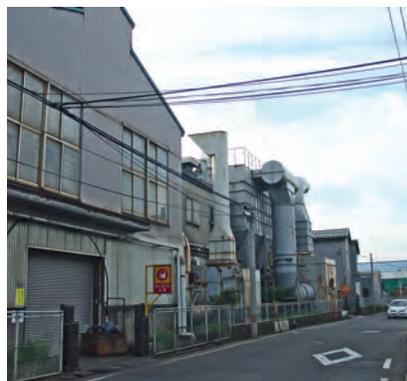
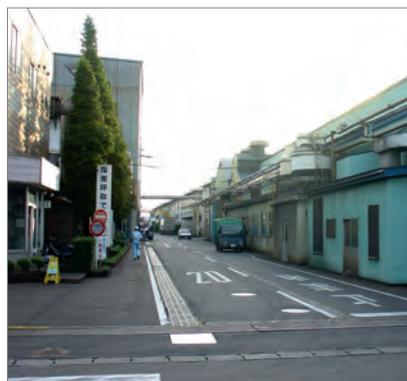
**Figure 6.** Some of the structures that were undamaged or lightly damaged at the piston ring manufacturing plant.

older manufacturing facility, with dozens of buildings and mostly relatively low-tech manufacturing operations. For the most part, the structures performed adequately (Figure 6) and did not contribute significantly to the roughly 10 days of loss of operations. That business interruption was caused almost entirely by damage to equipment. The primary cause of damage was the inadequate or non-existent anchorage of equipment. 1,240 out of 1,840 of heavy machinery (70%) slid or toppled during the earthquake. All of this damage could have been

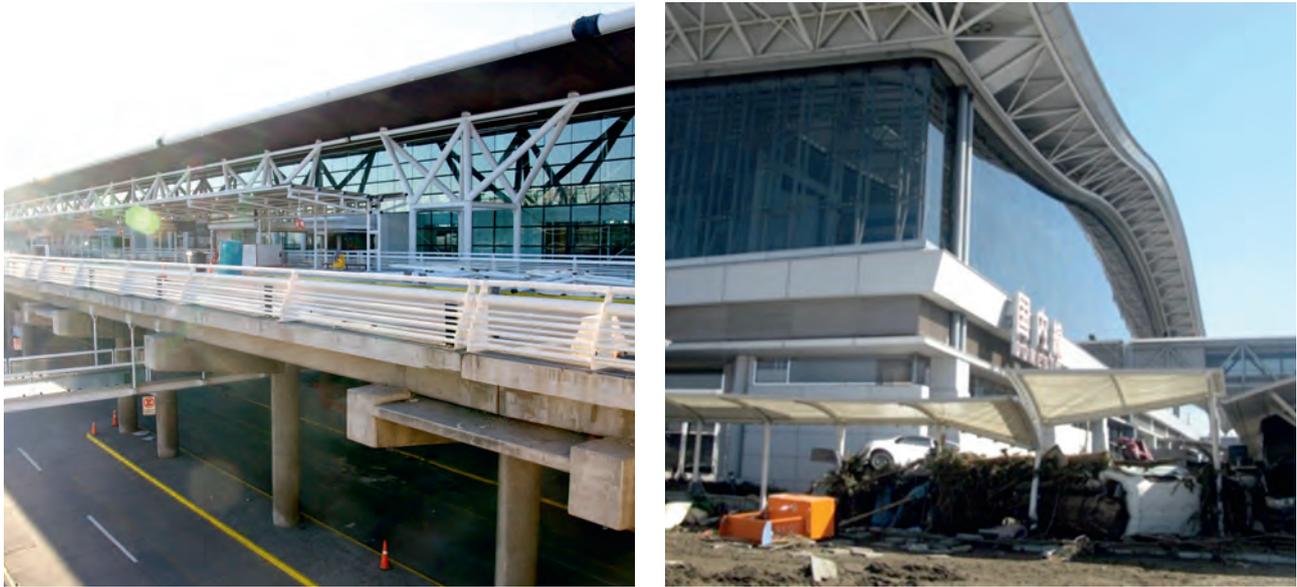
**Figure 9.** The new terminals at Santiago's International Airport (left) and Sendai's Airport (right). Both structures had light structural damage but extensive non-structural damage (and long business interruptions). Note the undamaged glass facades in both buildings. The lack of damage to the glass indicates that the structural design was excellent. The Sendai terminal suffered extensive tsunami damage to its first floor (the damage in the lower foreground).

including the Caribbean, Central and South America. A little structural engineering and a little more reinforcing steel in the right places of the concrete frame, such as can be seen

in **Figure 9**, made the difference between the successful buildings in Chile and the devastation of otherwise-similar buildings in Port-au-Prince, Haiti in 2010.

**Figures 9 and 10** (opposite) summarize the lessons to be learned. Modern buildings can perform well, or they can collapse. In Chile older modern buildings often performed better than new buildings. The difference in performance was due to the earthquake engineering details and systems built into the structures.

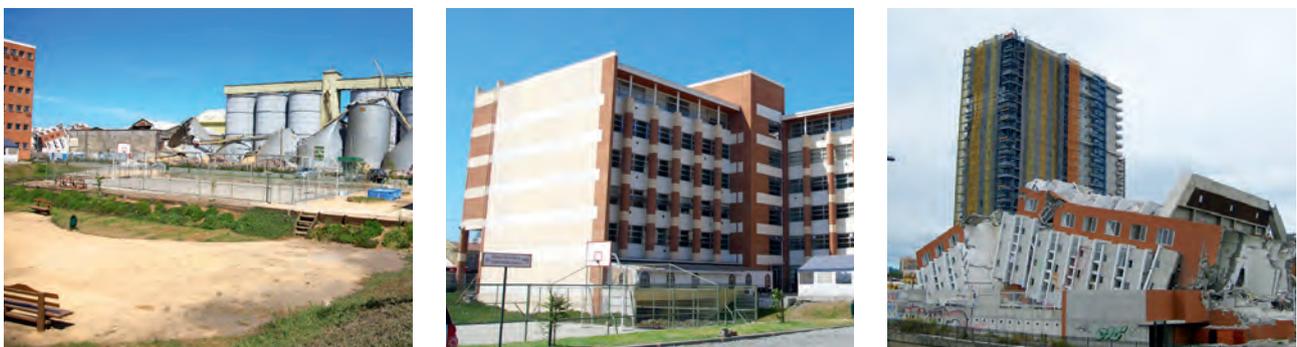
**Figure 10.** Three adjacent structures in Concepción, Chile are shown in the top photograph after the 2010 earthquake. The collapsed steel silos in the foreground of the first photograph are much newer than the much less damaged and much older steel silos in the back. The lightly damaged building in the left of the first photograph is shown in the middle photograph. It is much older than the collapse new tall apartment building in the third photograph. The collapsed building was new.
